BELL HELICOPTER TEXTRON FORT WORTH TEX
AH-1S HIGH-SURVIVABLE TRANSMISSION SYSTEM.(U)
OCT 77 D J RICHARDSON

USAAMRDL-TR-77-30

AH-1S HIGH-SURVIVABLE TRANSMISSION SYSTEM

Final Report for Period October 1975 - August 1977

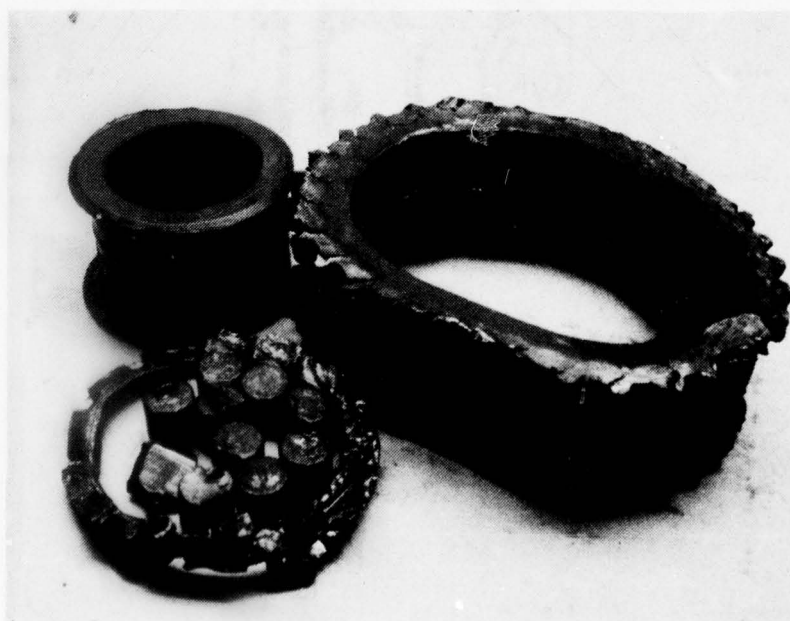
Figure 36. Lower planetary pinion, bearing inner race, rollers, roller guides, and retainer after 21-minute loss-of-lube retest of transmission number 1.

Following the 21-minute loss-of-lube test, the transmission was disassembled for a post-run inspection. Figures 35 through 50 show some of the disassembled components. The planetary pinions of the lower planetary stage were oblong and deformed. The teeth had softened and were flattened or stripped from the pinions. The planetary roller bearing cages were still recognizable but the tangs had been pressed into the center ring

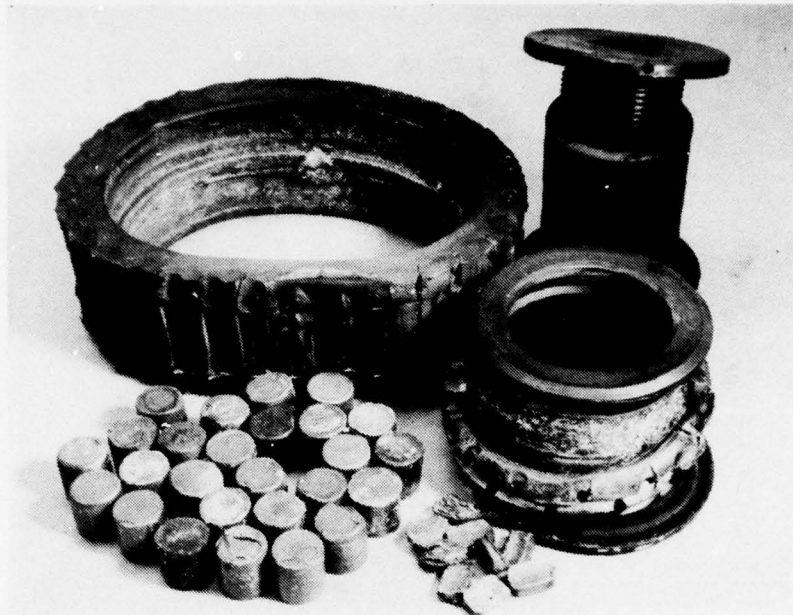
Figure 69. Oblong lower planetary pinion, bearing inner race, rollers, retainer, and roller guides after 19-minute loss-of-lube test of transmission number 2.

Disassembly of the transmission following the 19-minute loss-of-lube test revealed that this failure was very similar to the one which occurred after the 21-minute loss-of-lube retest of transmission number 1. Figures 67 through 82 show various components following the loss-of-lube test of transmission number 2. The teeth had been stripped from all four of the lower planetary pinions. One of the lower planetary pinions was oblong and deformed. Some of the rollers retained within this pinion were skewed sideways. The tangs which retain these rollers had broken off of the bearing cage. The other three lower planetary pinions still appeared round. The rollers were not skewed and were retained properly. The lower planetary sun gear teeth had softened and the center portion of the teeth had been rolled over in a manner similar to the sun gear of the 21-minute loss-of-lube test of transmission number 1. The upper and lower ring gears were covered with a carbon residue but the teeth had not softened like the lower planetary pinions or the lower ring gear.

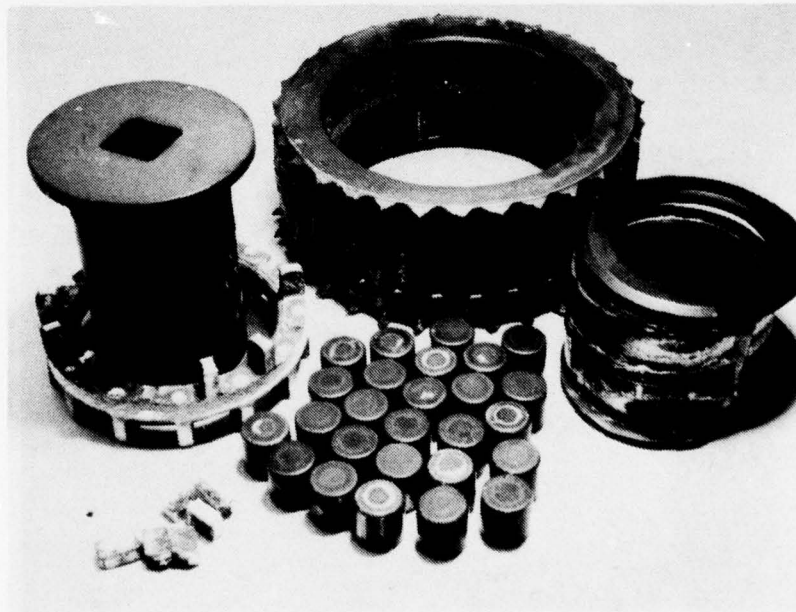
Figure 70. Lower planetary pinion (typical of 3 of the 4 pinions), bearing inner race, rollers, retainer, and roller guides after 19-minute loss-of-lube test of transmission number 2.

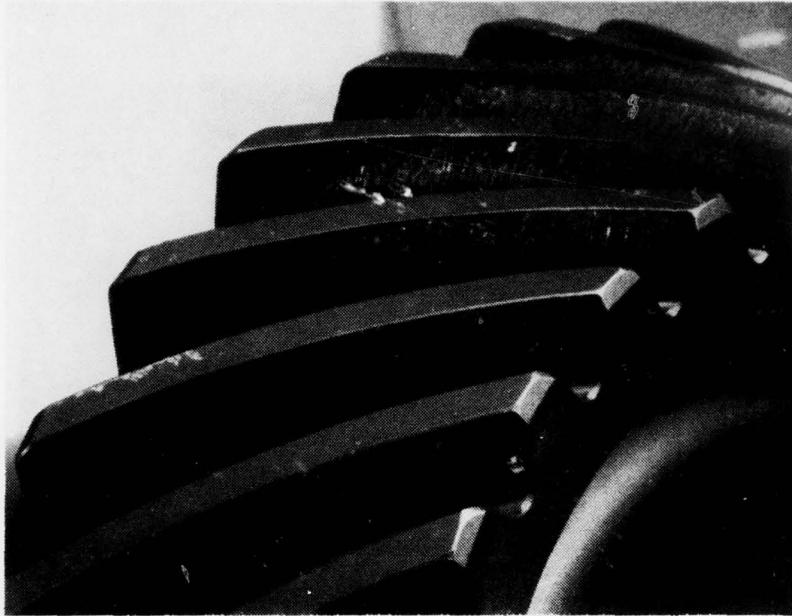
Figure 77. Main input pinion teeth (drive side) showing moderate scoring after 19-minute loss-of-lube test of transmission number 2.

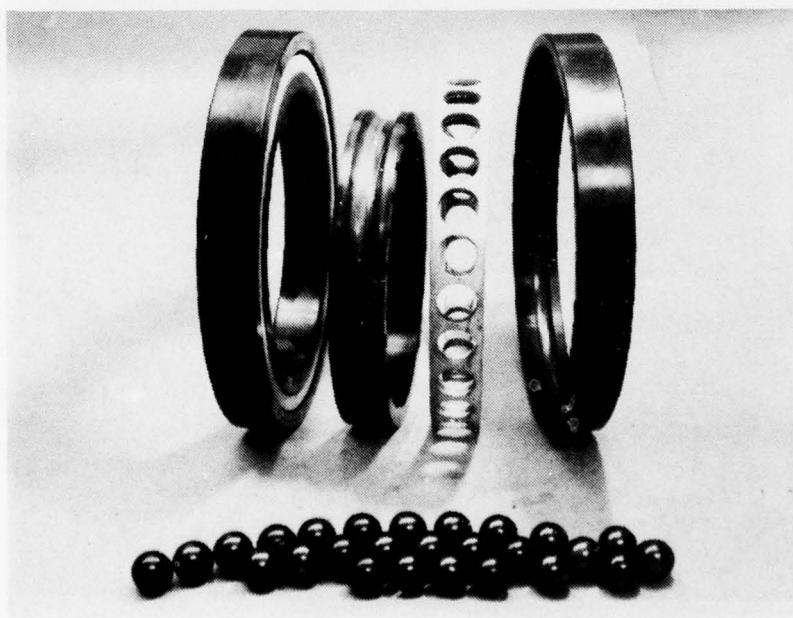
Figure 80. Main gearshaft duplex bearing after 19-minute loss-of-lube test of transmission number 2.

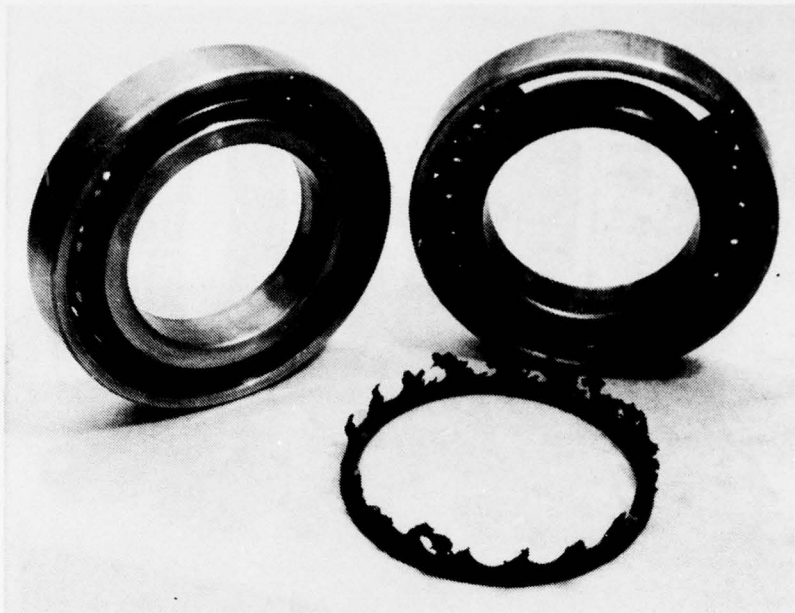
Figure 81. Fan accessory drive duplex bearing showing melted nylatron retainer after 19-minute loss-of-lube test of transmission number 2.

The fan drive accessory quill which is located on the forward side of the main case and driven by the main input gear (204-040-701-1) utilizes a duplex ball bearing with a nylatron retainer. The nylatron retainer in the inboard bearing of this duplex pair had melted during the 19-minute loss-of-lube run (reference Figure 81). The bearing was still operational, however, and the fan operated until transmission operation ceased.

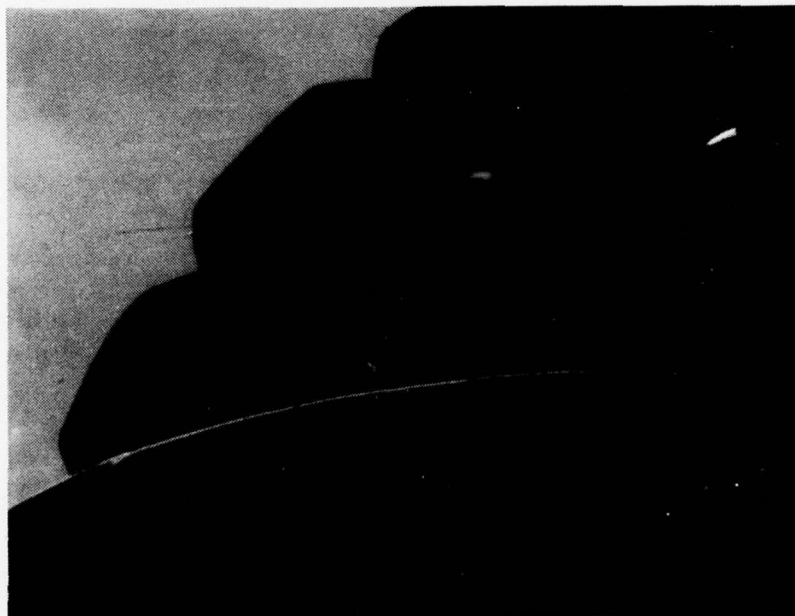
Figure 82. Tail rotor drive, sump input gear (drive side) showing light scoring after 19-minute loss-of-lube test of transmission number 2.

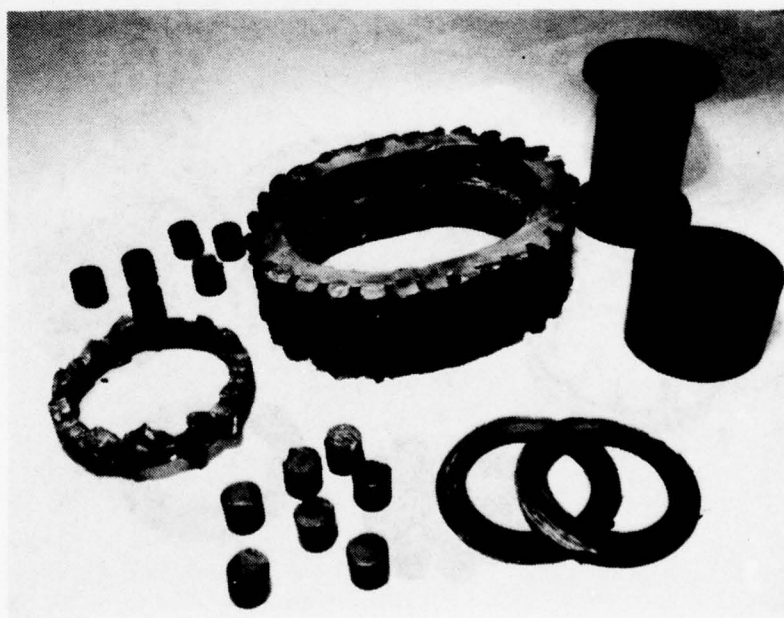
Figure 99. Lower planetary pinion, bearing, inner race, rollers, retainer, and roller guides after fourth loss-of-lube test.

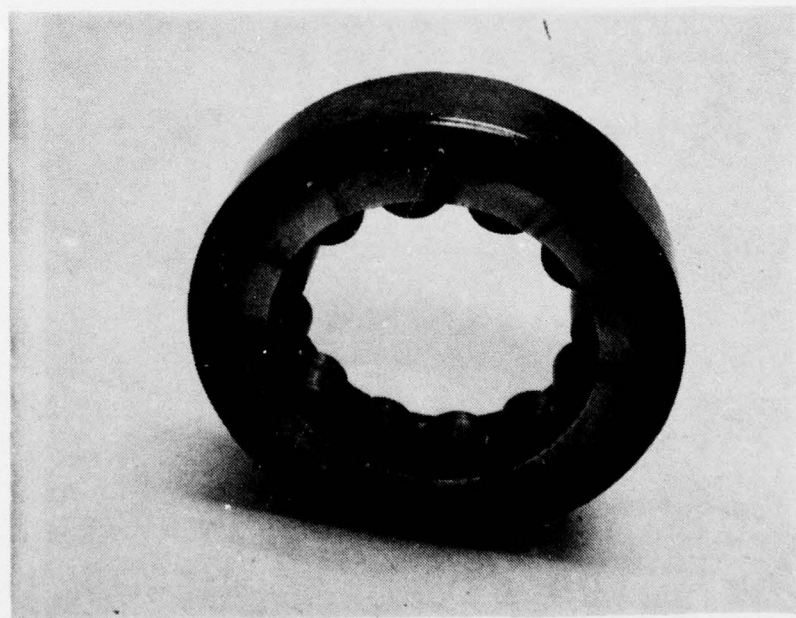
Figure 111. Input pinion roller bearing following fourth loss-of-lube test.

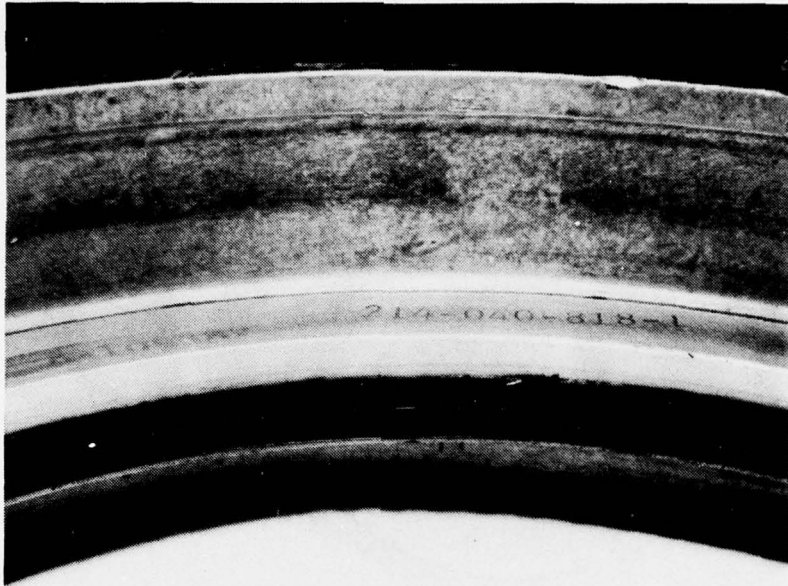
Figure 112. Main input carbon radial seal after fourth loss-of-lube test.

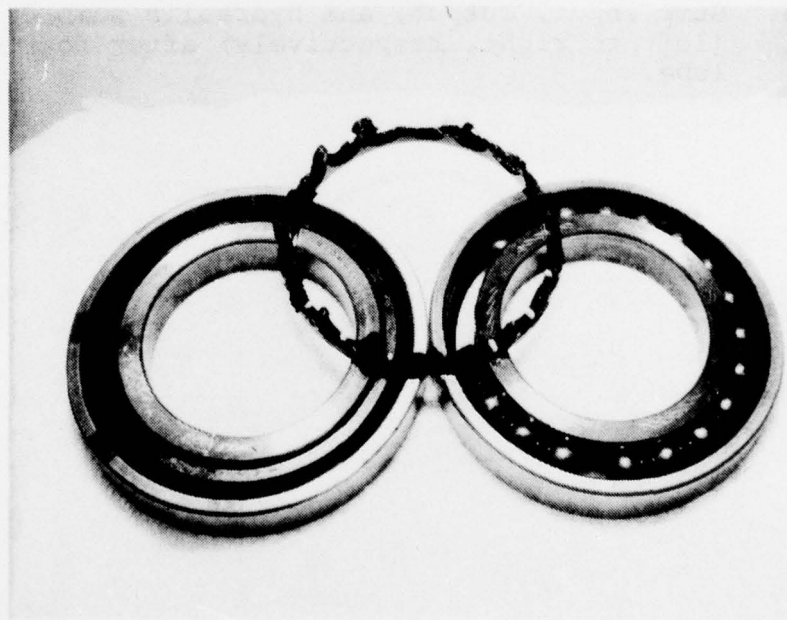
Figure 115. Fan accessory drive duplex bearing after fourth loss-of-lube test.

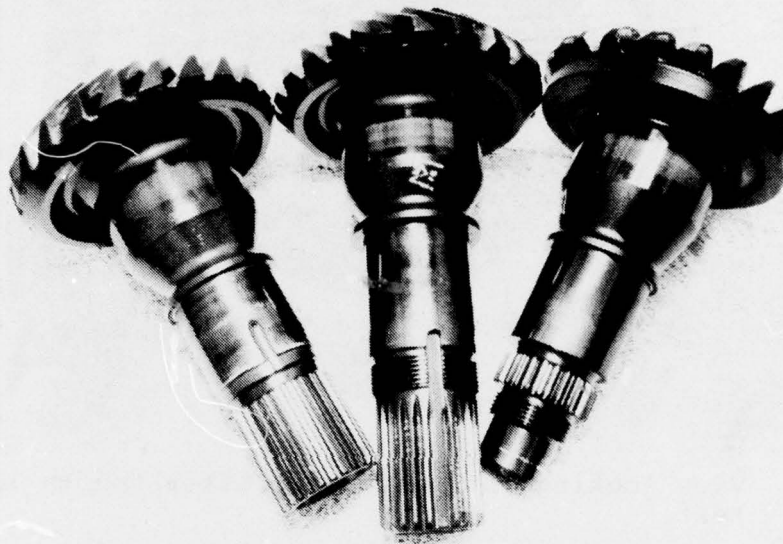
Figure 116. Sump input, output, and hydraulic pump drive gears (left to right, respectively) after fourth loss-of-lube.
